# MANN+HUMMEL FM600 Oil Cleaning Centrifuge Maintenance Procedure

Applicable for the FM600-11/12/13/14/19 series Centrifuge Range

# OIL CONDITIONING SYSTEMS SPARE PARTS LIST

# FM600 - 11/12/13/14/19 SERIES

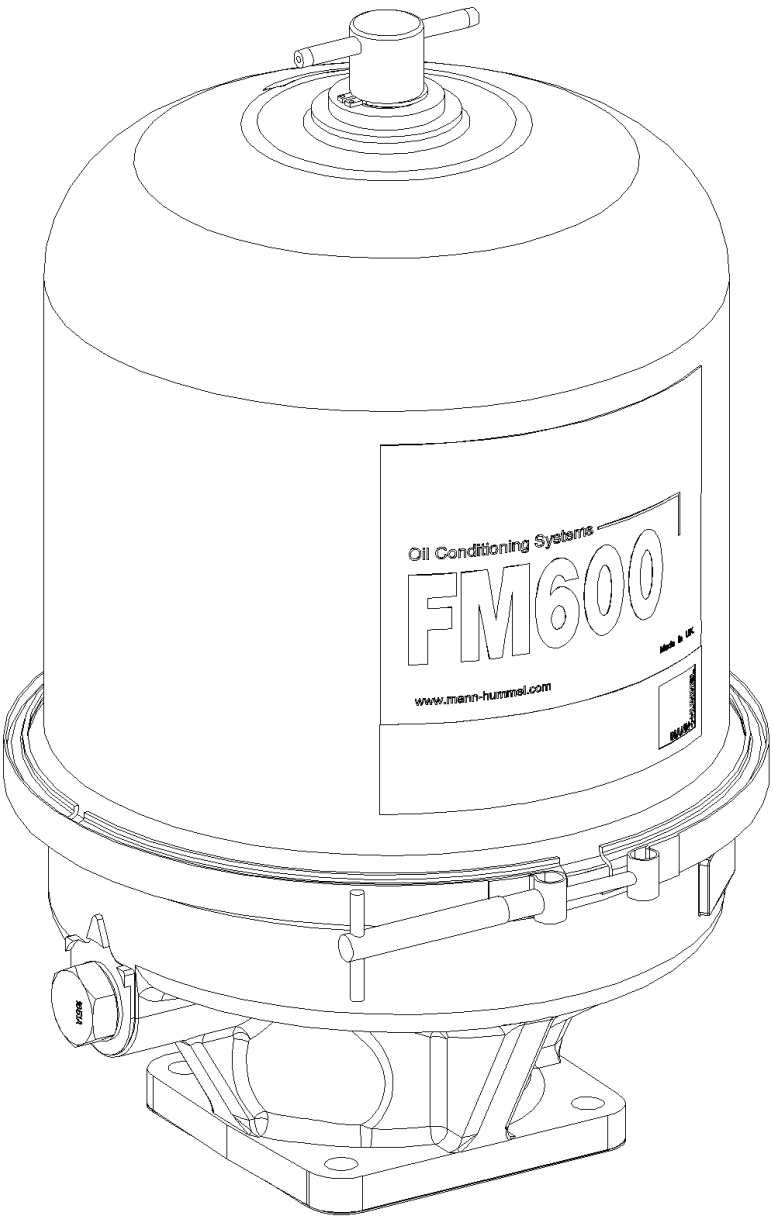
# Spare Parts List

ROTOR ASSEMBLY	04155A	1	●	●	●	●	
	04189A	1					●
NOZZLE	4903A	2	●	●	●	●	●
BEARING TUBE ASSEMBLY	05153A	1	●	●	●	●	
BEARING TUBE ASSEMBLY	05169A	1					●
SEPARATION CONE	33193A	1	●	●	●	●	●
CIRCLIP	1205P	1	●	●	●	●	●
PAPER INSERT (NOT ILLUSTRATED)	3028A	1	●	●	●	●	●
ROTOR TOP	4647A	1	●	●	●	●	●
ROTOR BASE	4458A	1	●	●	●	●	●
ROTOR TUBE	4451A	1	●	●	●	●	●
